Fatality #1 - February 12, 2011
Machinery - Florida – Phosphate Rock
C F Industries Inc - Hardee Phosphate Complex

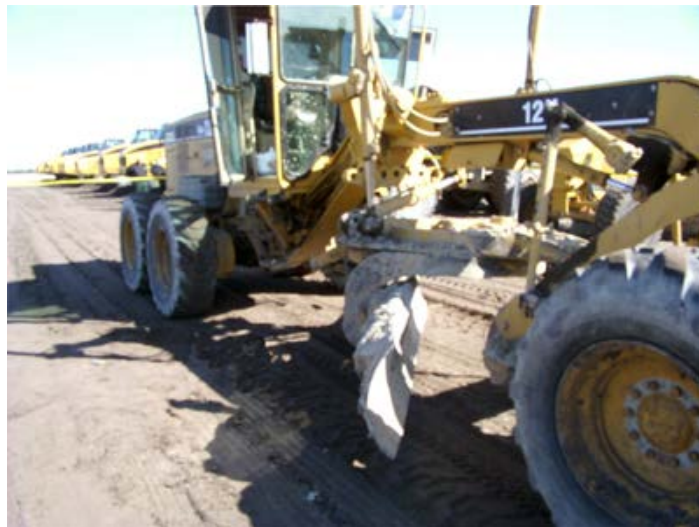
METAL/NONMETAL MINE FATALITY - On February 12, 2011, a 41 year- old grader operator with 15 years of experience was killed at a phosphate rock operation. The victim and a coworker were standing and talking when he was struck by a grader that was backing up. The accident occurred in a staging area where equipment operators were inspecting their equipment before the shift.

- Train all persons to recognize work place hazards and to stay clear of normal paths of travel for mobile equipment.
- Regularly monitor work practices and reinforce their importance. Take immediate action to correct unsafe conditions or work practices.

- Designate a specific area, clear of mobile equipment, where persons can meet before the shift starts.
- Install cameras and collision avoidance systems on mobile equipment to protect persons.

- Ensure that illumination is adequate at the work site.
- Before moving mobile equipment, look in the direction of travel, use all mirrors, cameras, backup alarms, and installed proximity detection devices to ensure no one is in the intended path.

- Sound the horn to warn persons of movement and allow time to move to a safe location.
- Communicate with mobile equipment operators and ensure they acknowledge your presence.

- Wear high visibility clothing when working around mobile equipment.
- Consider use of wearable strobes when near mobile equipment.
